**INTERNATIONAL JOURNAL OF RESEARCH IN  
AERONAUTICAL AND MECHANICAL ENGINEERING****“IMPROVEMENTS TO OPENING AND CLOSING APPRAISAL  
METHOD OF LOW PRESSURE STEAM TURBINE  
PERFORMANCE PREDICATION”****H.G.PATIL<sup>1</sup>, V.G. ARAJPURE<sup>2</sup>**

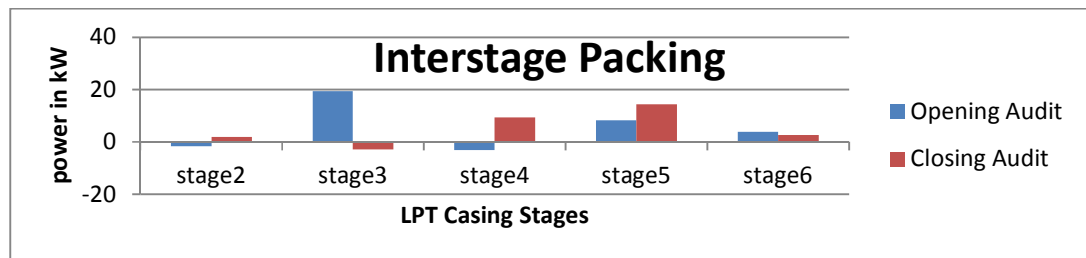
**Figure 1 Opening Audit Vs Closing Audit for Inter Stages Packing of power losses in KW for LP casing****Table 5 Opening Audit of Total Interstage Packing for LPG casing**

The opening audit loss due to increased inter-stage packing clearances was 47.4kW and the heat degrade 0.74kJ/kWh. Most of the tooth circumference, of both inter stage of LP stages, was found with a rounded tooth profile, which passes more flow. The closing audit loss when compared to original design clearances were 98.8kW and the heat rate degrades 1.54 kJ/kWh. This has gain losses as clearances were not corrected in respect to design.

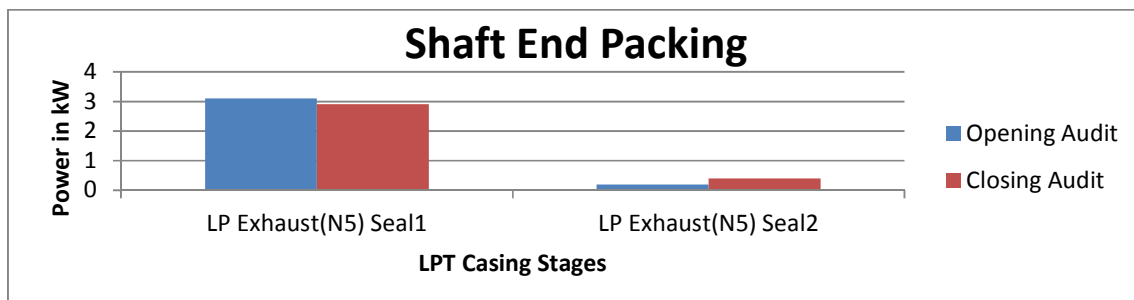
**Figure 3 Opening Audit Vs Closing Audit for Shaft End Packing of power losses in KW for LP casing****Table 11 Opening Audit of Total Shaft End Packing for LPG casing**

The opening audit loss due to increased end packing clearances was -5.8kW and the total heat rate degraded - 0.09kJ/kWh. This closing audit loss due to increased end packing clearances was -5.7kW and the total heat degraded -0.09kJ/kWh.

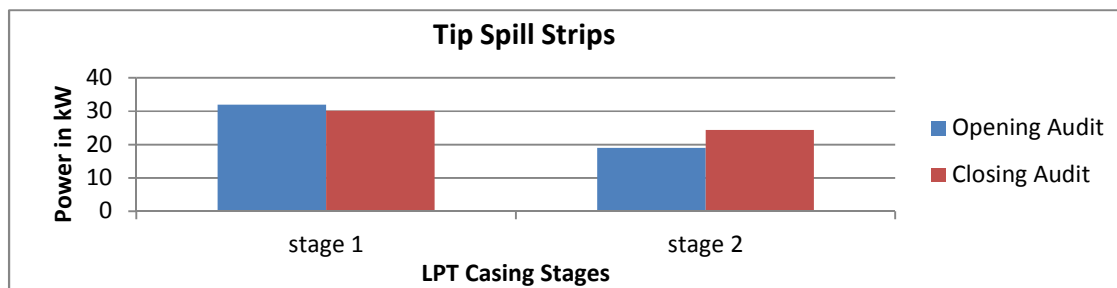
Figure 5 Opening Audit Vs Closing Audit for Tip Spill Strips of power losses in KW for LP casing

The opening audit loss due to increased Tip Spill Strips clearances was 89.4kW and the to heat rate degraded 1.39kJ/kWh. This closing audit loss due to increased Tip Spill Strips clearances was 109.2kW and the heat degraded 1.7kJ/kWh.

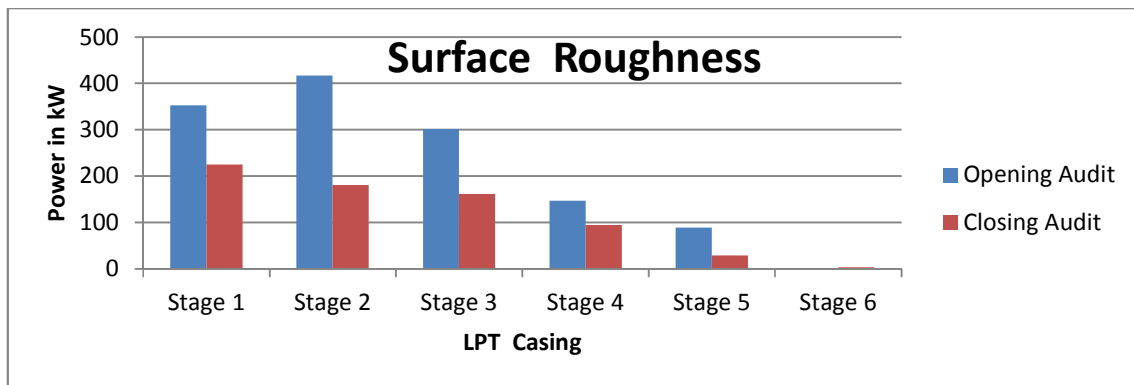
**Figure 7 Opening Audit Vs Closing Audit for Surface Roughness of power losses in KW for LP casing****Table 23 Opening Audit of Total Surface Roughness for LPG casing**

The opening audit evaluation of the surface roughness showed a loss of 2924.5kW and an increase in heat rate of 45.63. Surface Roughness of closing audit loss when compared to original design was 1441.9kW and an increase in heat rate of 22.46kJ/kWh. COH recovered 5221.6Kw.
