Experimental Study on Natural Frequency of Composite Box Beam for Multiple Cracks

Abstract

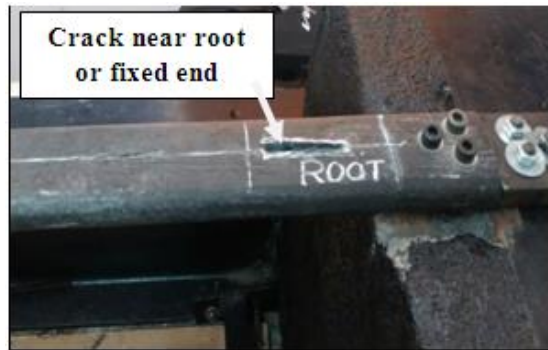
For damage analysis first crack is produced near fixed end of the beam. The crack is produced manually of 50 mm length, width 5 mm and depth 4 mm. The damaged beam is fixed like a cantilever beam. Then, analysis is carried out for beam with only one crack. The proposed setup for this analysis is same as undamaged beam. The composite box beam with root crack is shown below.

Figure 3: Damaged beam by producing crack near root **Figure 4:** Damaged beam by producing crack at mid

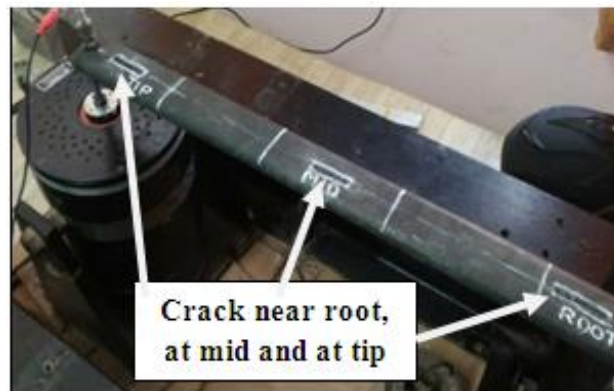
Figure 5: Damaged beam with multiple cracks

In this case, one additional crack is produced at tip (free end) of the beam. Then, this damaged beam with multiple cracks is used for analysis. In this condition the natural frequency of beam is reduced up to 29.375 Hz. The beam with three is shown below.
